RISK AREAS FOR DEVELOPMENT DUE TO UNDERMINING CONSTRAINTS THREE SISTERS RESORTS

Three Sisters Golf Resorts Inc. - #1003

TO: The Mayor and Town Council of Canmore
RE: Three Sister's Resorts Proposed Development

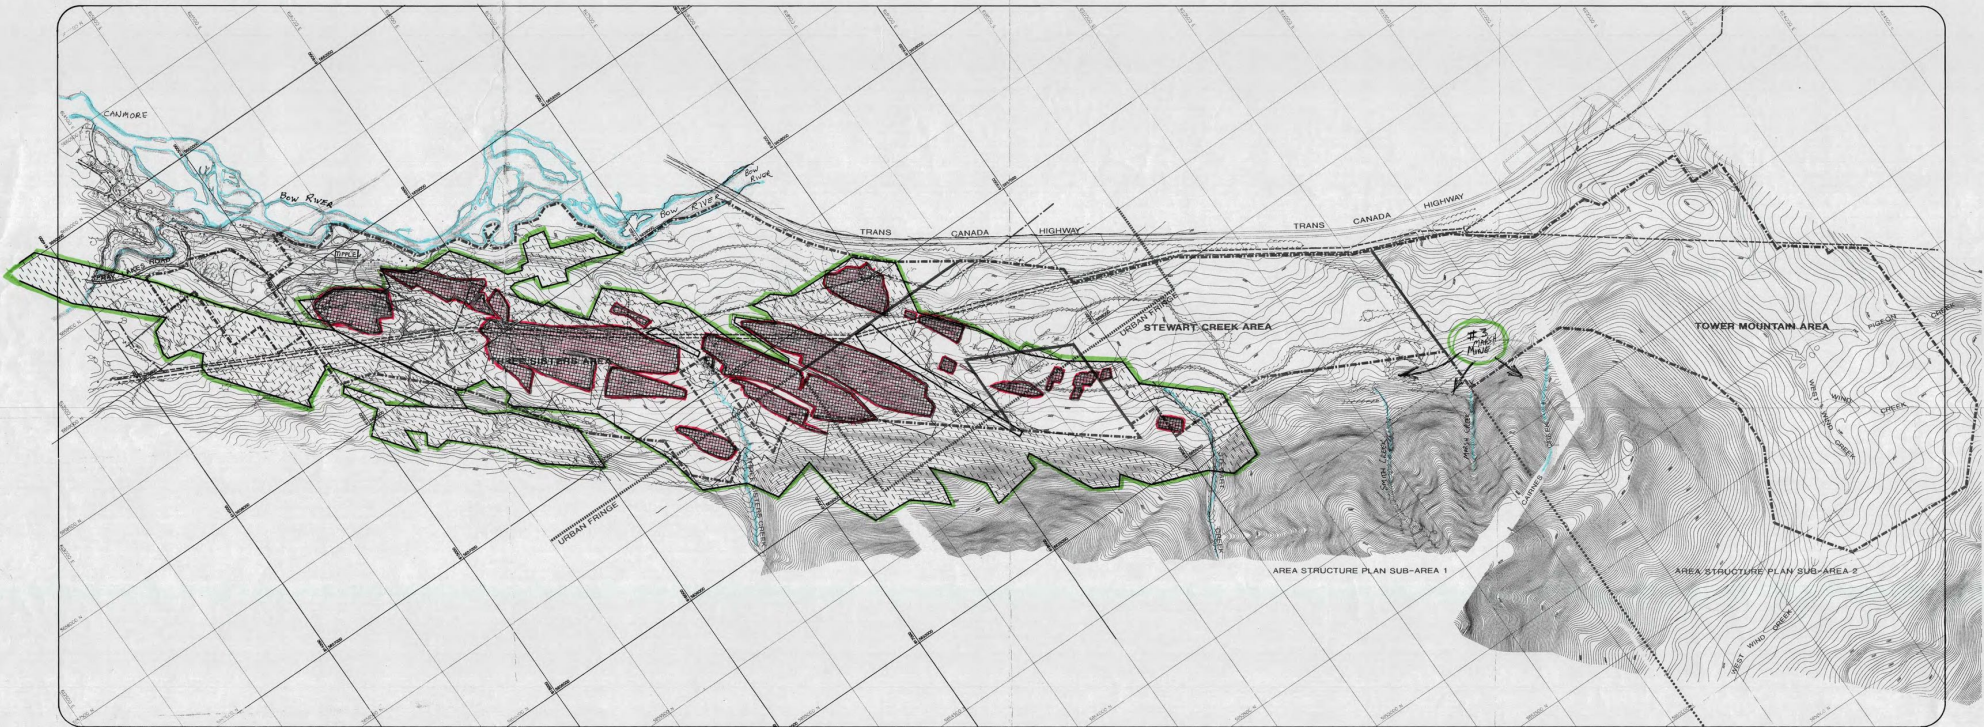
MAP "A"

LEGEND:

**NON DEVELOPMENT**
-

**RESTRICTED DEVELOPMENT - EXTRACTION**
-

**RESTRICTED DEVELOPMENT - DRIVEAGES**

NO. 3 MINE (MARSH MINE - PROSPECT)

DESCRIBED BY DERRICK STEELE
AS ONE OF THE GASSEY MINES (METHANE)
IN NORTH AMERICA

While working on the guidelines, a unanimous decision was made by the Committee and was site specific. Only a golf course was considered to be viable (with a caveat). That decision by the Undermining Committee was based on the following geotechnical hazards and the UWM constraint Map A associated with this specific area:

Derek Steele was looking at constraint Map A when TSR consultant Gerry Stephenson suggested we head to the site of the proposed golf course. Derek Steele proceeded to tell Gerry that we would not be visiting the site because there were areas on site too dangerous to walk on and should not be included as part of the golf course. He also said that some of the sites picked by TSR for club houses would have to be moved because of the hazards and subsidence dangers associated with the underlying vertical coal seam workings and pointed to the Non Development Risk Areas highlighted on UWM constraint map submitted by TSR to the Town of Canmore. (see Map A)

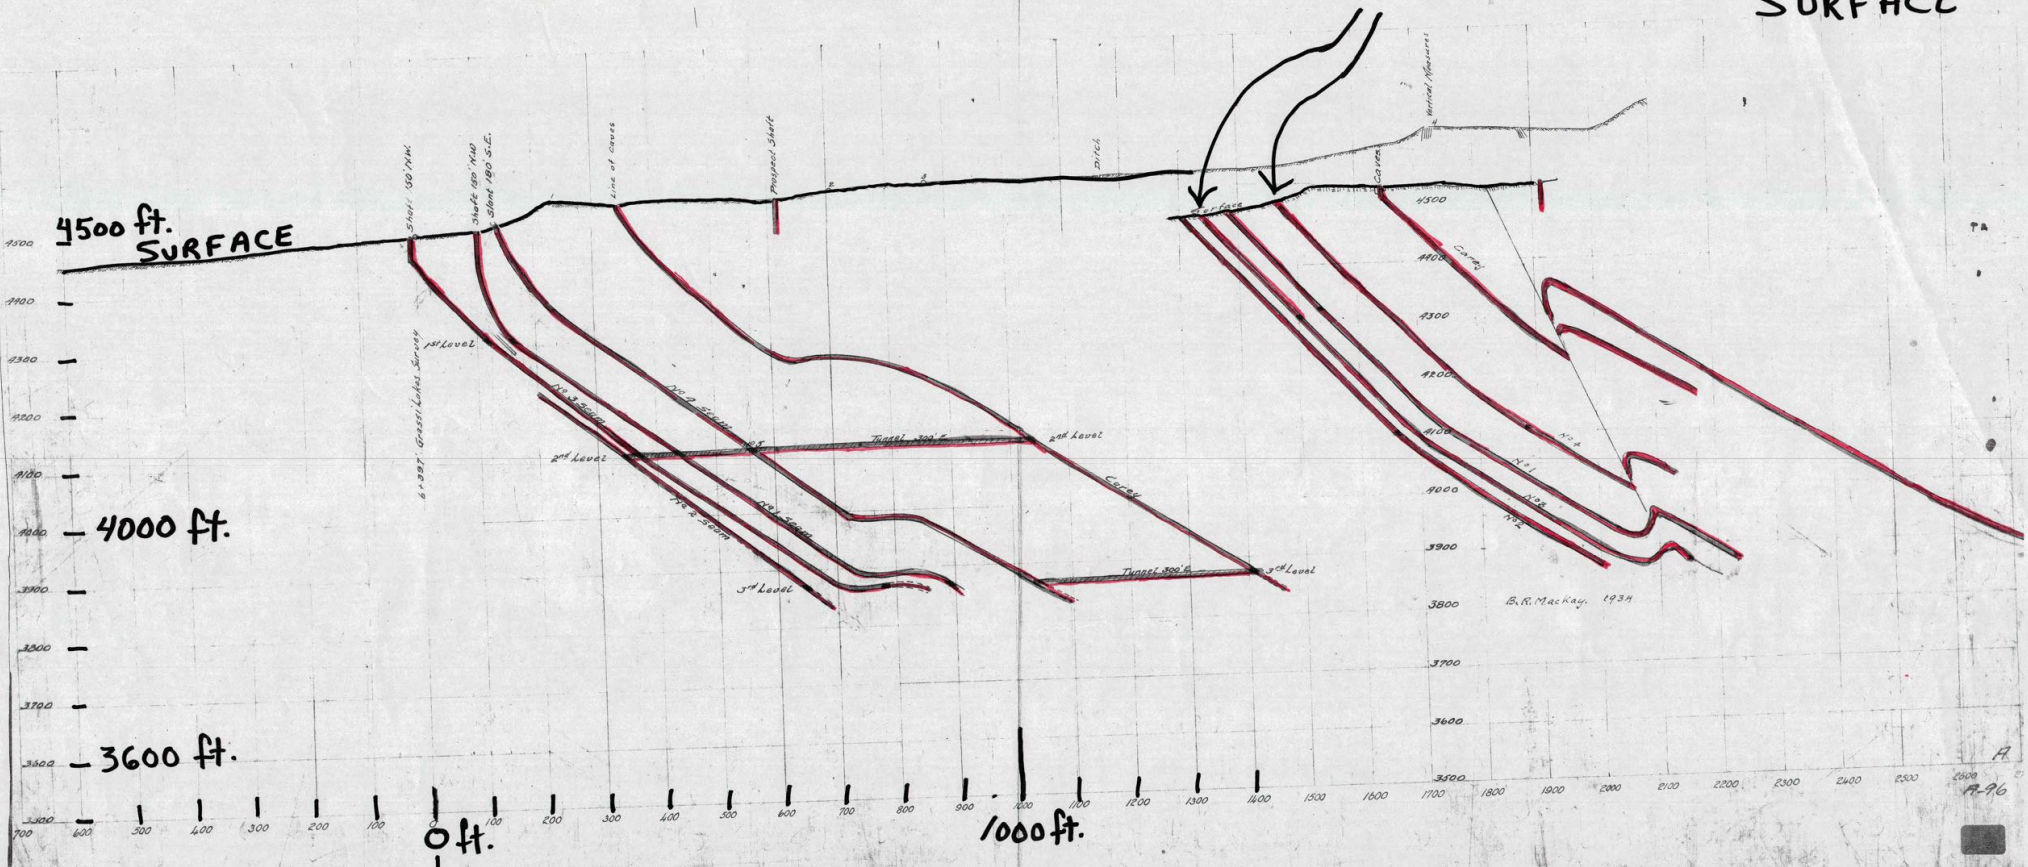
VERTICAL SECTION A

SHOWS SEAMS MINED
TO 10 feet to 15 feet
BELOW
SURFACE

SEAMS: No. 1, No. 2, No. 3, No. 4, and CAREY
connected by 3 levels of TUNNELS
S. HAMILA WORKED WITH MACKAY CUTTING & SURVEY LINES (1933-34)
(GRASSI LAKES SURVEY)

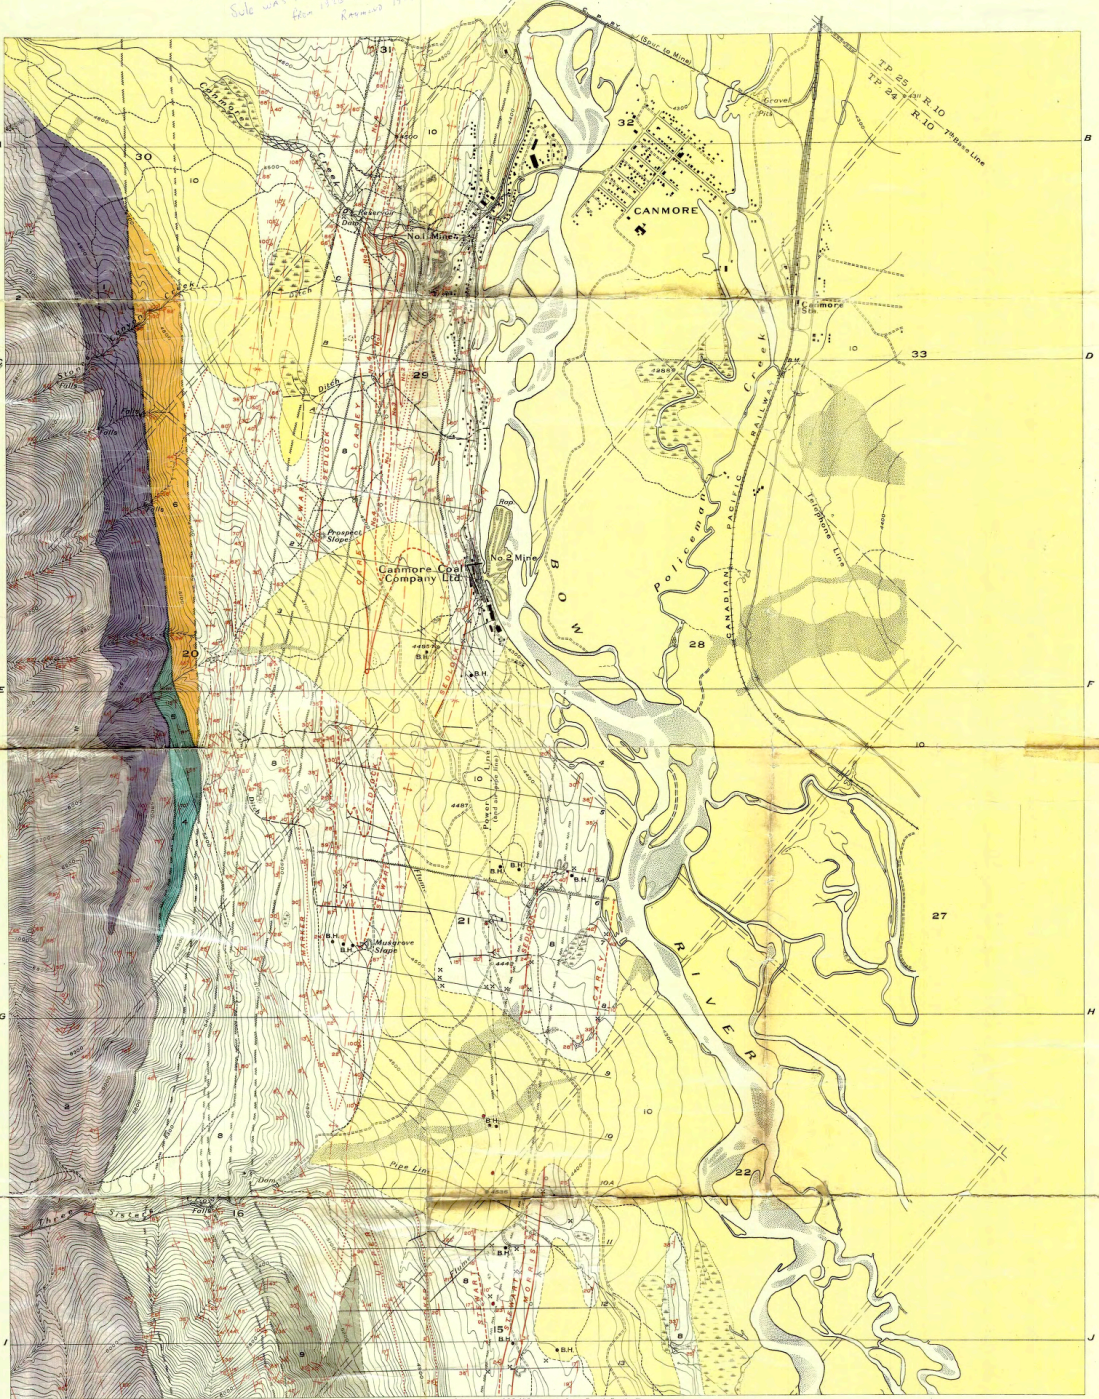
MAP 322 A
(PUBLICATION No. 2382)
NORTH PORTION
CANMORE AREA
(WEST OF FIFTH MERIDIAN)
ALBERTA

Scale: 8200 or 1 inch to 800 Feet

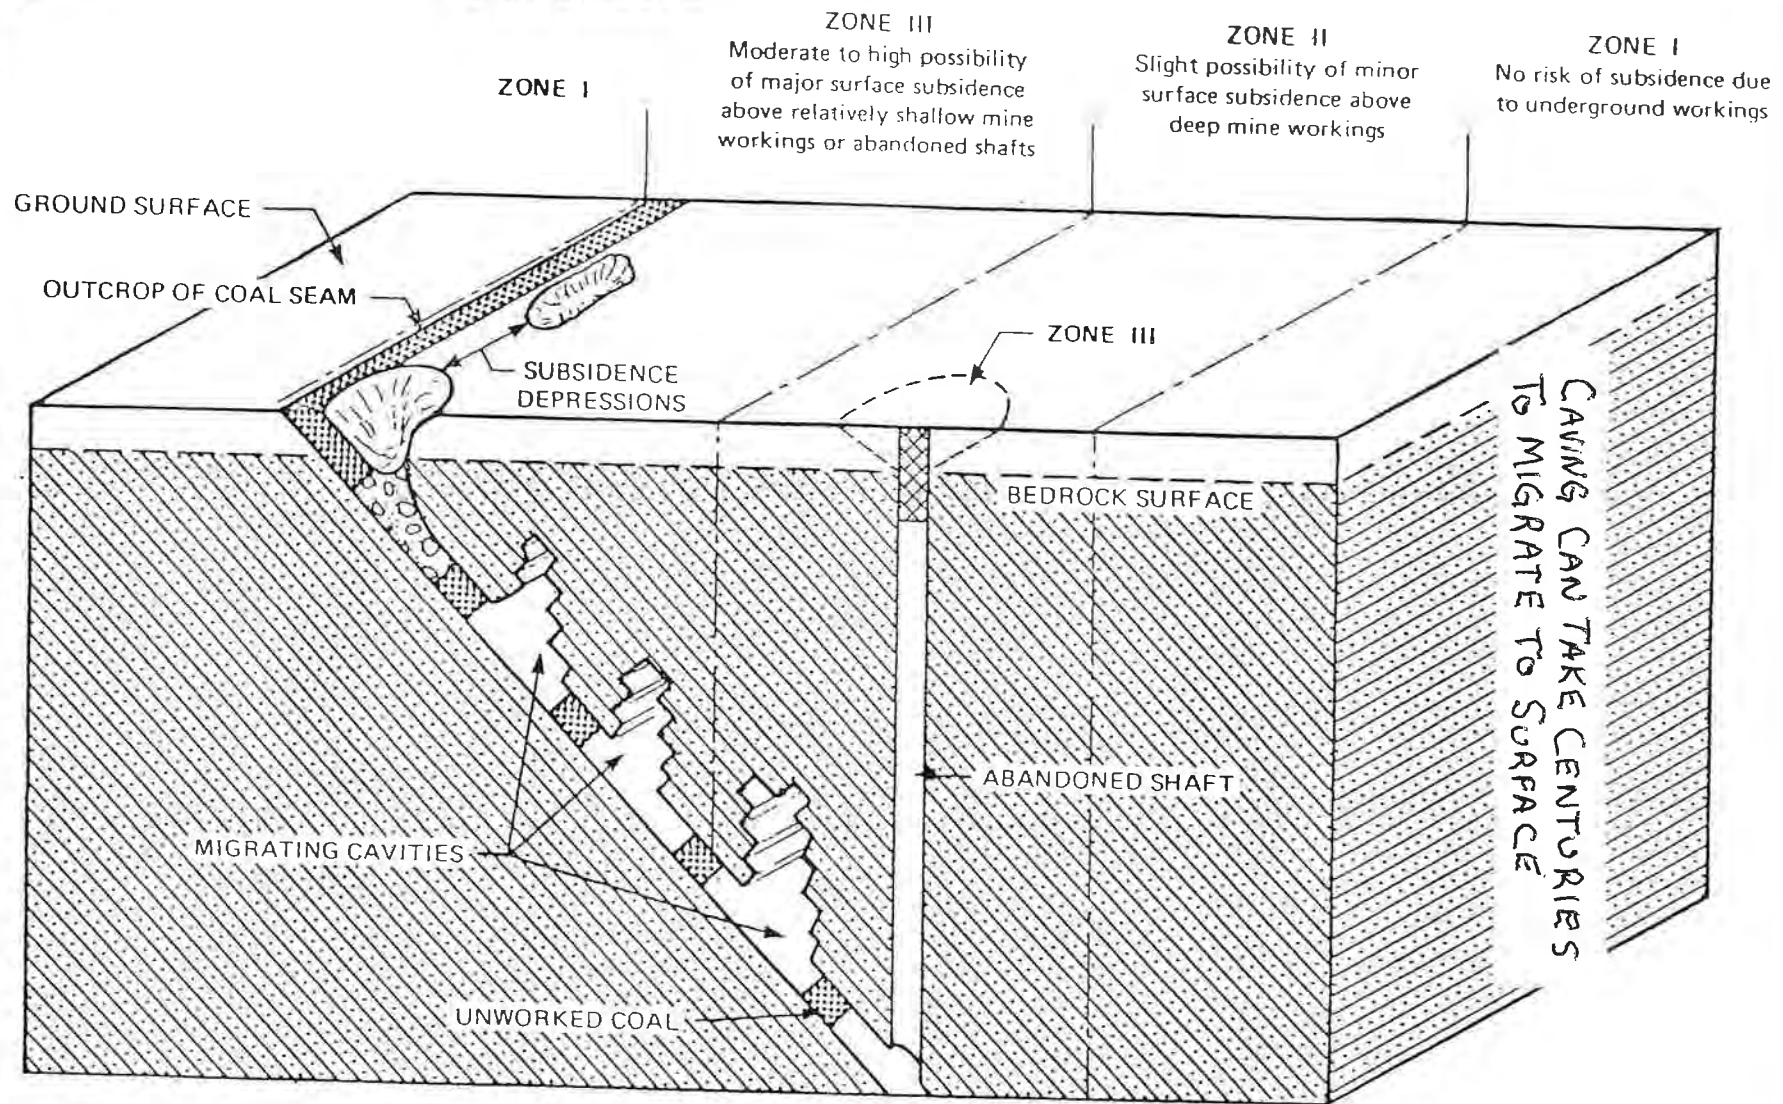
FLOODING ACCELERATES THE MOVEMENT OF DEBRIS FROM CAVING DOWNSLOPE

FIGURE 8 SCHEMATIC DIAGRAM SHOWING A PROBABLE RELATIONSHIP BETWEEN WORKINGS ON A DIPPING COAL SEAM AND ASSOCIATED SUBSIDENCE RISK ZONES

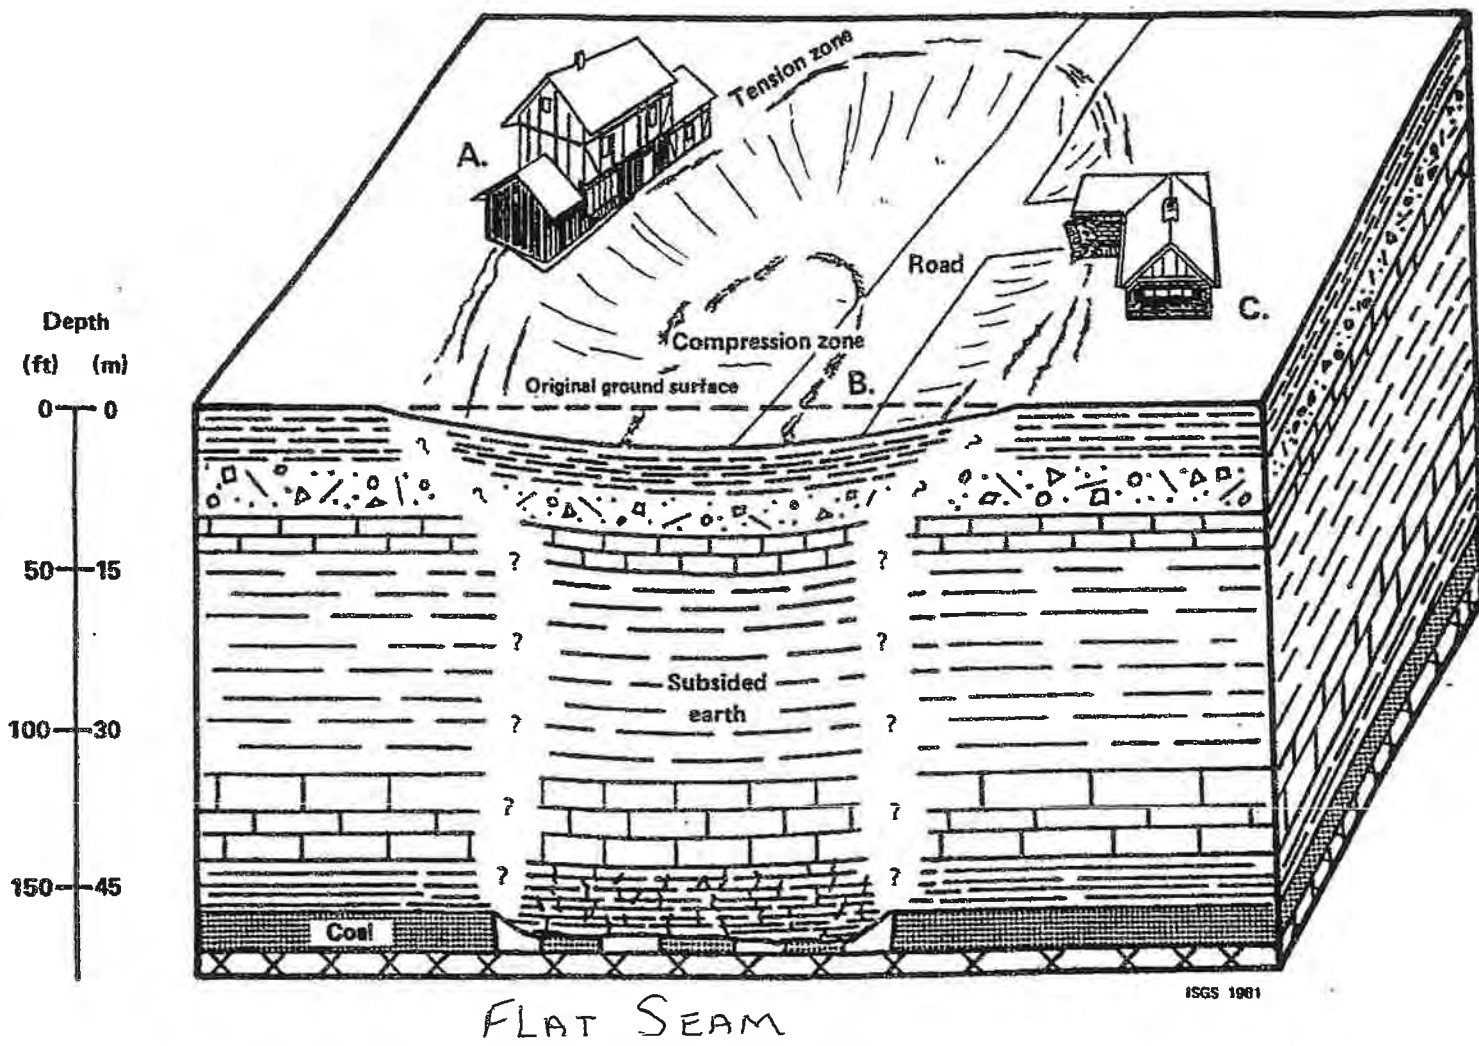
SAG OR DOWN WARPING IS MORE COMPLICATED OVER UNDERMINING OF MULTIPLE DIPPING SEAMS WHEN COAL IS CLASSIFIED AS FRIABLE

Figure 10. Block diagram of a typical sag subsidence event:

- A. Wooden frame house in tension zone. Foundation has pulled apart and dropped away from the superstructure in one corner.
- B. Road in compression zone. Asphalt has buckled.
- C. Brick house in tension zone. Walls, ceilings, and floors have cracked.

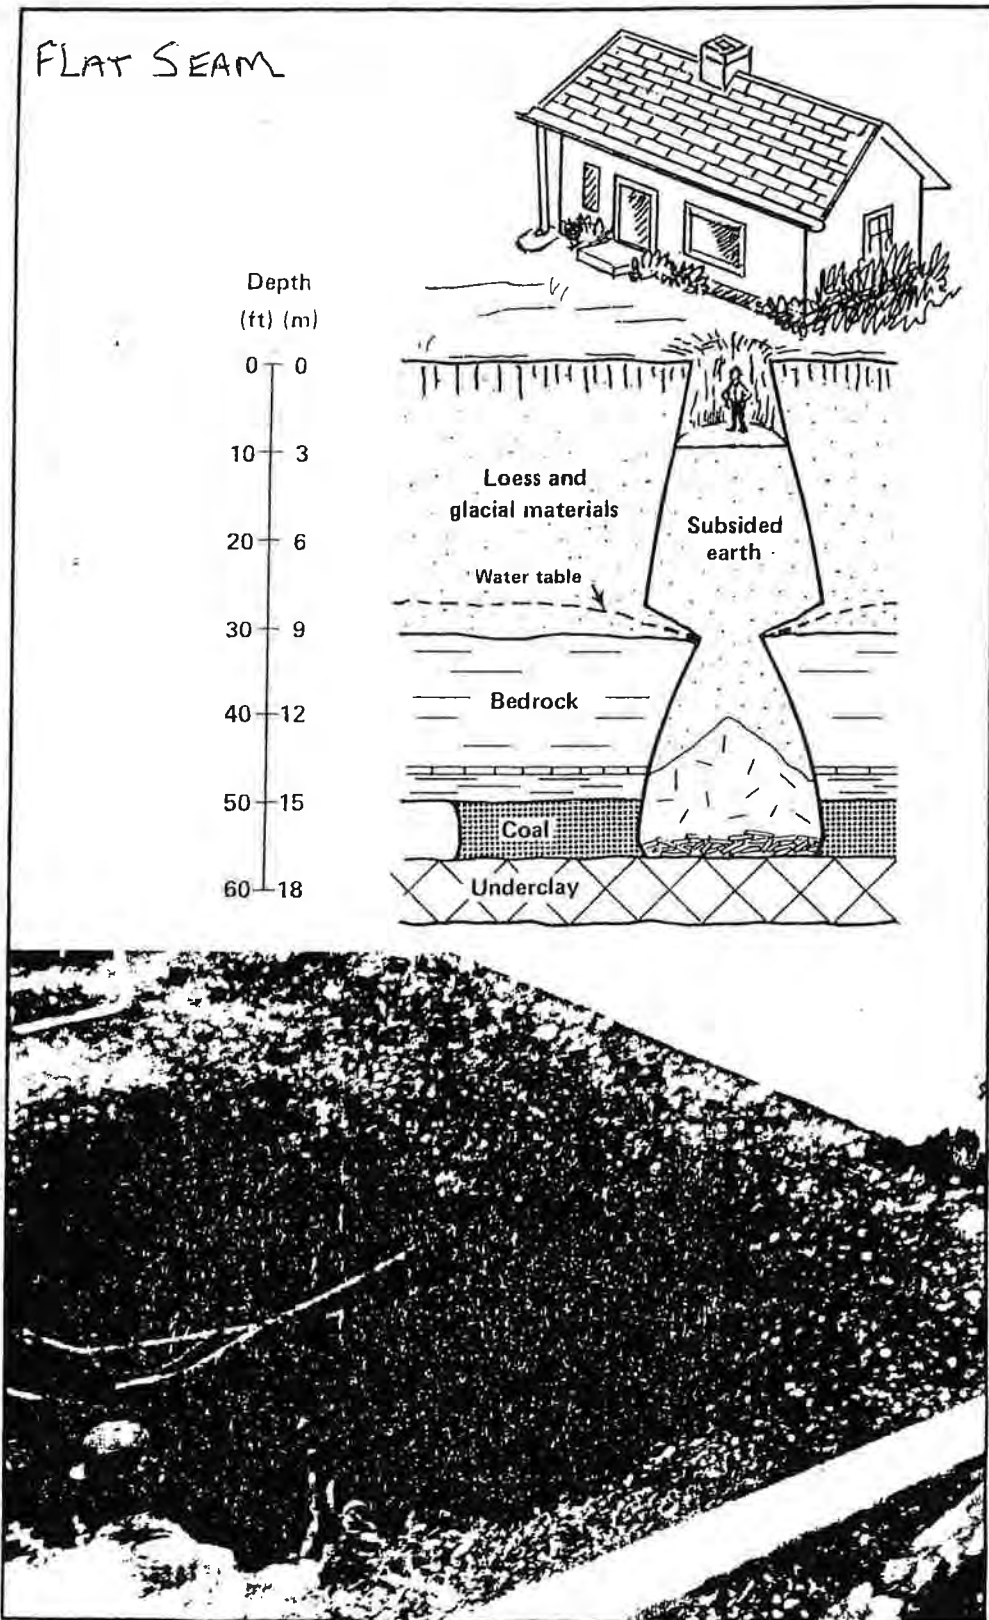
PIT SUBSIDENCE IS VERY COMPLICATED IN CARMORE
MULTIPLE SEAMS / DIPPING SEAMS / FRIABLE COAL

Figure 8. Cross section and photograph of a typical pit subsidence event (after Wildanger et al., 1980).

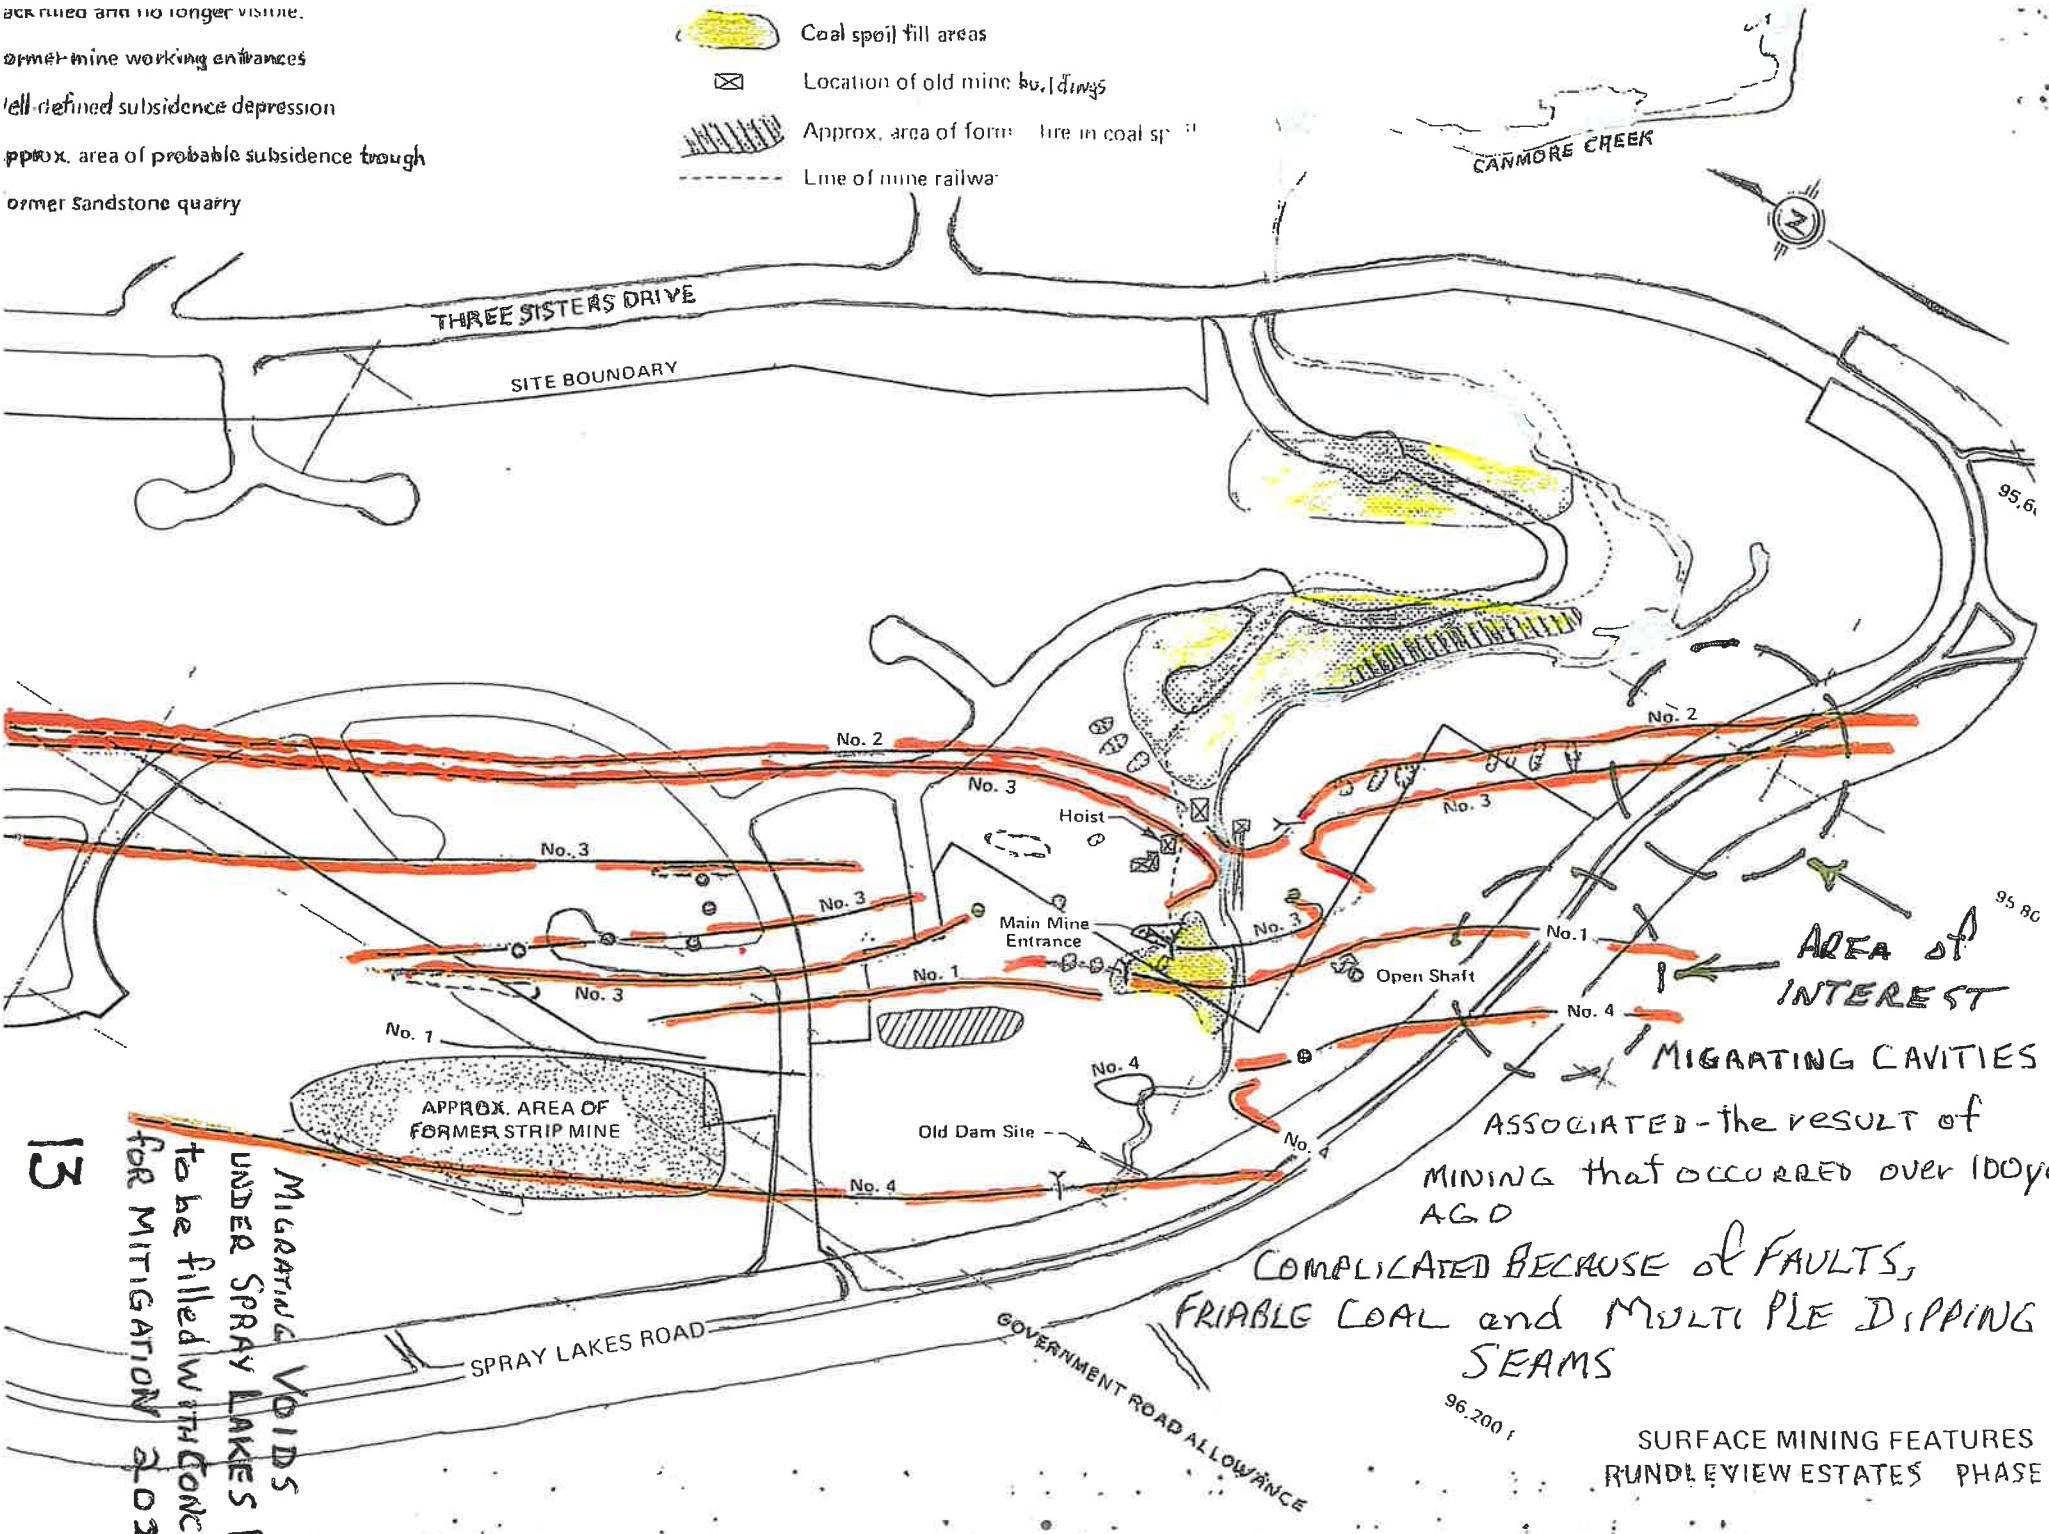
AREA OF INTEREST
 MIGRATING CAVITIES
 ASSOCIATED - the result of MINING that OCCURRED over 100yrs AGO

COMPLICATED BECAUSE OF FAULTS,
 FRIABLE COAL and MULTIPLE DIPPING SEAMS
